THE ROMBO PROJECT

AGRISYNERGIE
DONOR REPORT

**REPORTING PERIOD:
FEBRUARY 2023 - JULY 2023**

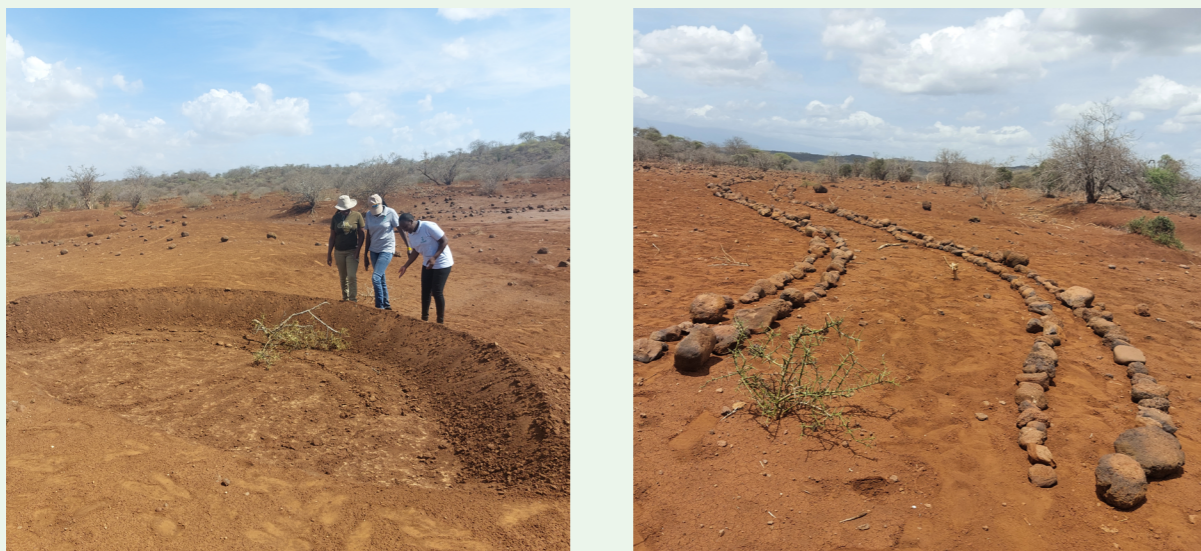
FIGURE 2 & 3: ROMBO BUNDS AND STONE LINES DURING BUND DIGGING IN JAN 2023

The digging of bunds was successfully concluded in January 2023, resulting in the construction of a total of 14,400 bunds. This achievement not only met the project's initial target of 48,000 bunds but also exceeded it by an additional 100 bunds. Simultaneously, the process of seeding the bunds was carried out. Drone photos showed germination and growth of vegetation after one rain rainfall event. Throughout the rainy season from March to April 2023, the region only experienced one rainfall episode. Drought conditions have continued to be a significant challenge and a threat to the local communities situated within the project site. As a result, this situation has increased grazing pressure in the bund sites.

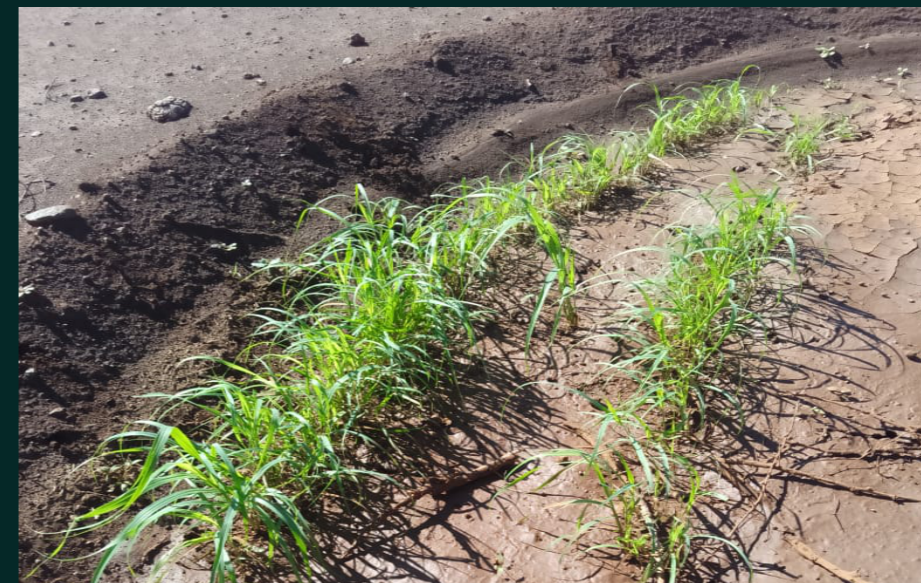
FIGURE 4: GRASS SPROUTED AND GREW INSIDE THE BUNDS AFTER APRIL 2023 RAINS

Following a single rain shower in April this year, the grasses that were planted within the bunds sprouted. Currently, the project has entered its maintenance phase, with rangers actively present on-site to oversee monitoring and protection of the area. To ensure effective management and utilization of grazing resources, a comprehensive grazing tool will be used. This tool will play a pivotal role in promoting sustainable grazing practices. In the upcoming weeks, we will organise training sessions for the grazing committee members to familiarise them with the utilisation of the grazing tool.

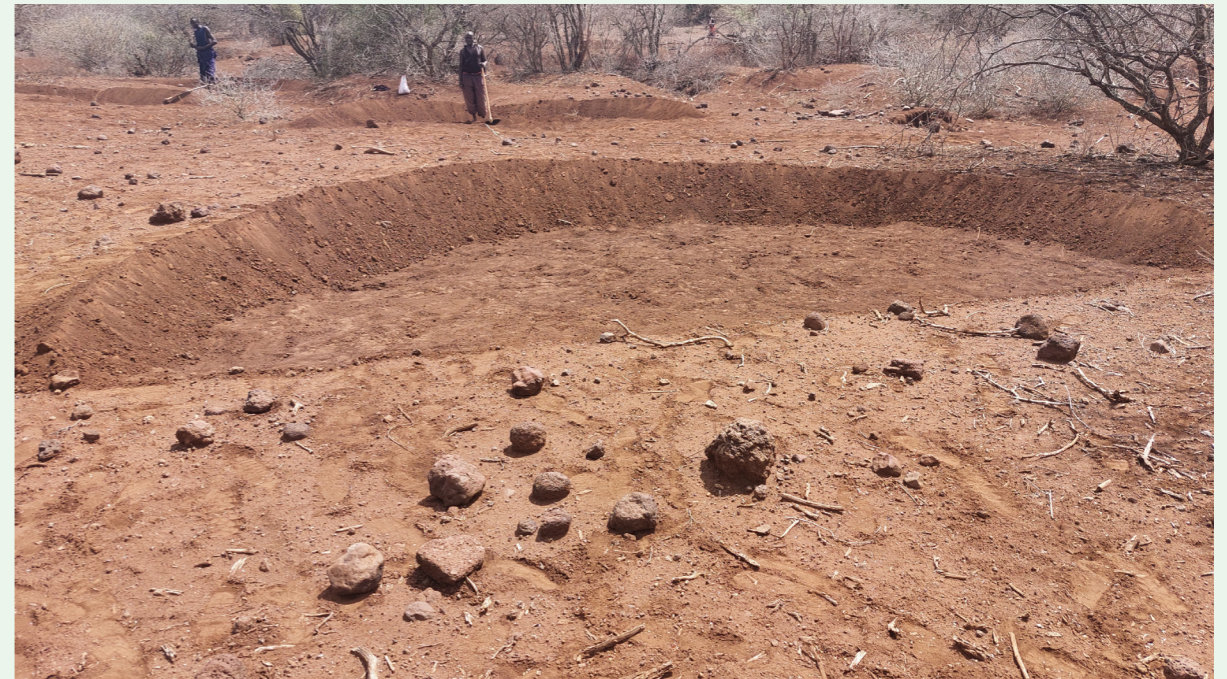
FIGURE 6: A BUND IN THE ROMBO BUND SITE IS VERY BARE BEFORE THE RAINS IN JANUARY DURING THE DRY SEASON

The photographs below are taken on the Rombo bund site. The first one is captured in January prior to the rains, and the others in May after the rainfall. These images visually highlight the transformation and impact of the project's efforts!

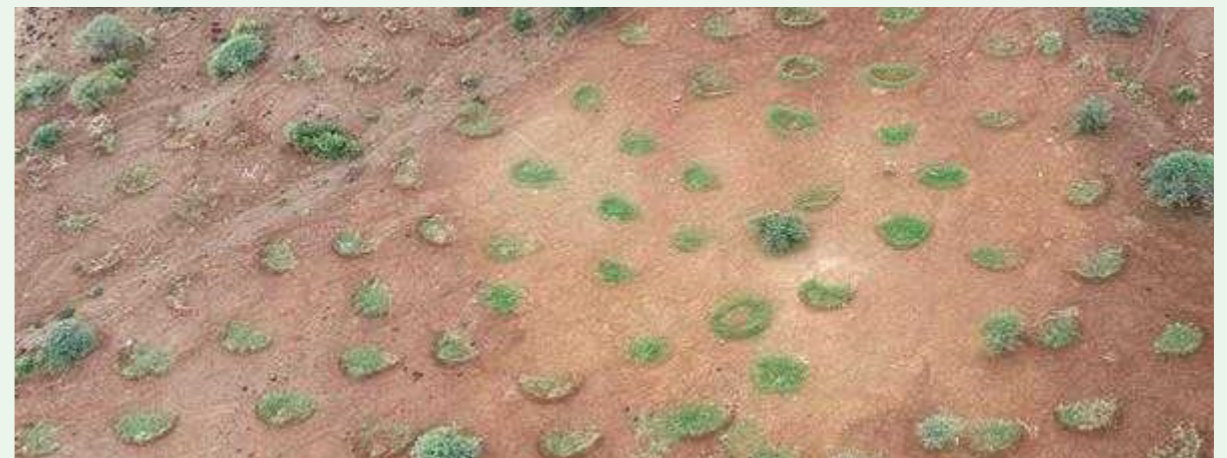
FIGURE 7: ROMBO BUNDS AFTER RAIN SHOWERS IN JUNE 2023

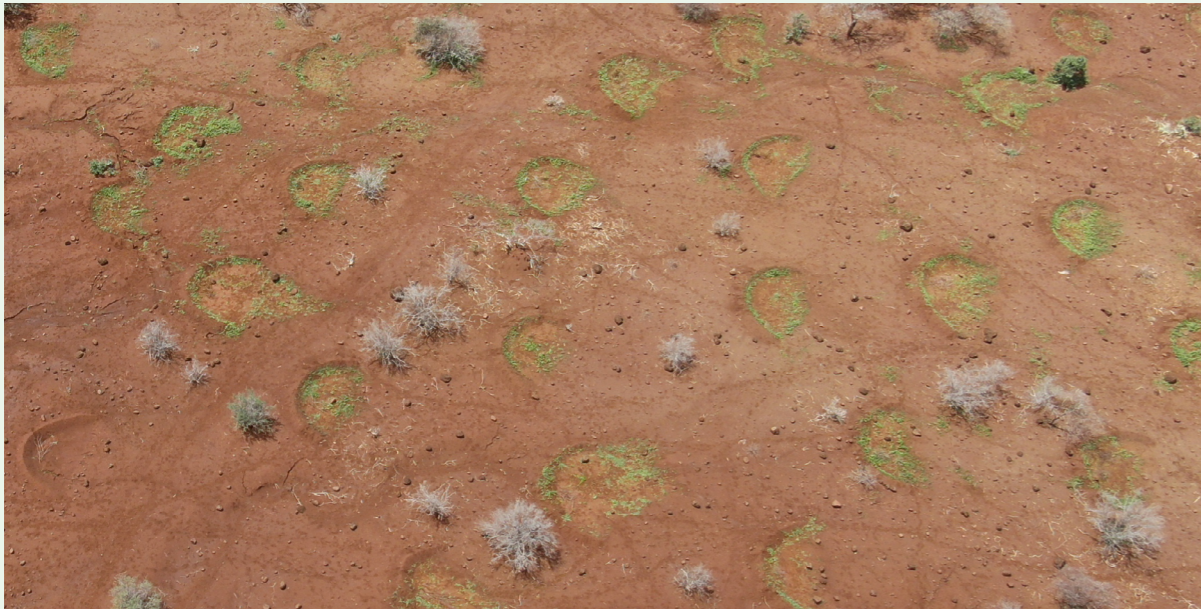
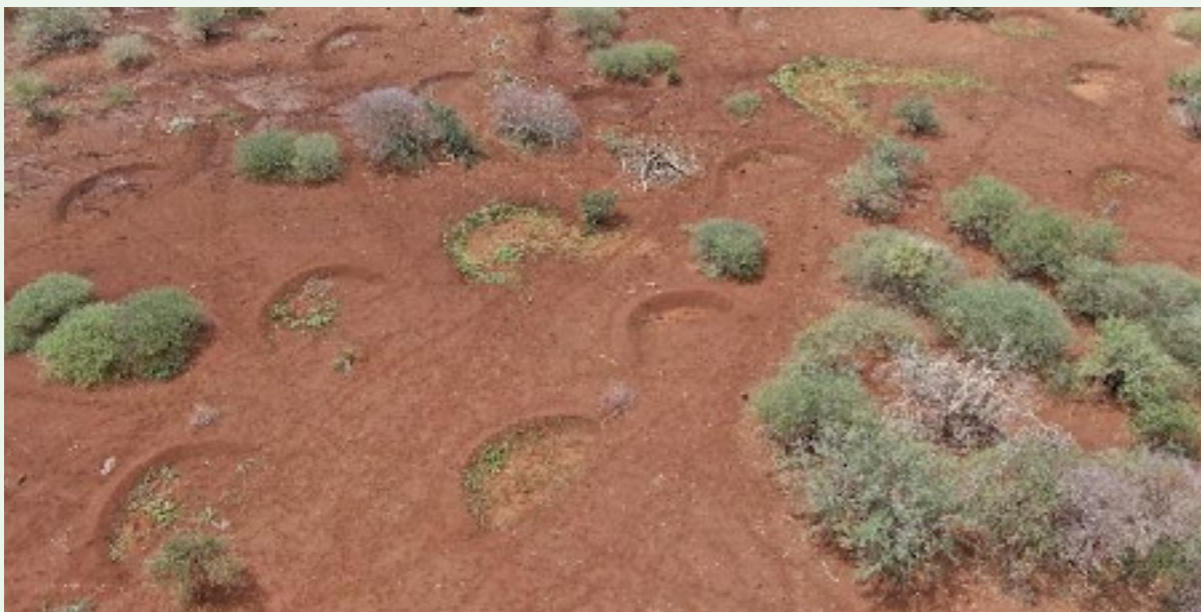
FIGURES 8 & 9: ROMBO BUNDS DRONE PICTURES IN MAY 2023 AFTER JUST ONE RAIN SHOWER
